Phase I Environmental Site Assessment

Ute Highway Water Treatment Plant

4651 & 4652 Ute Highway

Terracon Project No. 22117704

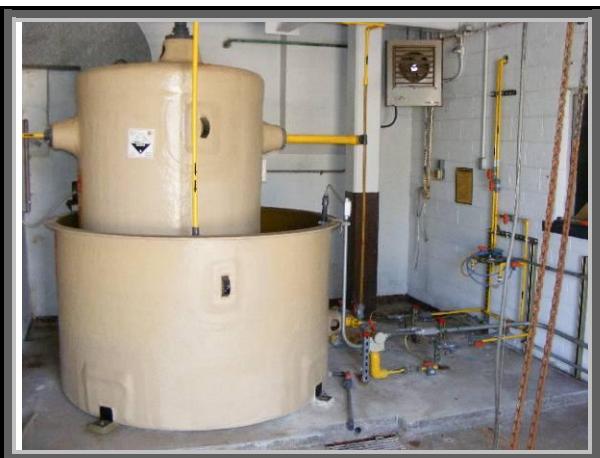
Photograph 15: Bleach/Chlorine storage room located in the basement of the Main Building.

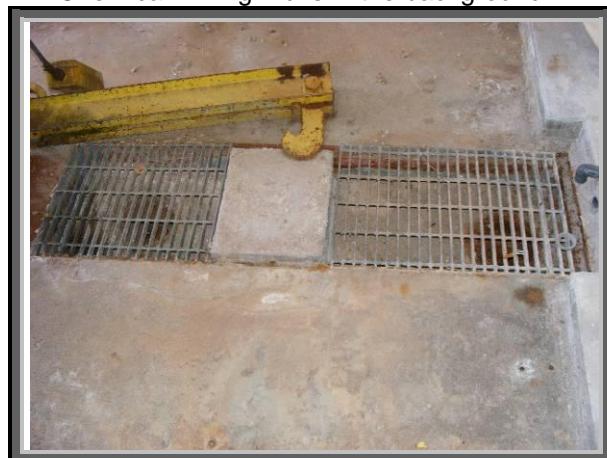
Photograph 16: Interior floor drain in the Bleach/Chlorine Room.

During the site reconnaissance, Terracon observed interior floor drains in all of the buildings on site. According to Mr. Talbott the interior floor drains discharge into a site perimeter drainage system. The perimeter drainage system reportedly handles the interior floor drains and site storm water runoff, and discharges into a ditch on the north side of Highway 66, at the southeast corner of the North Plant. Terracon observed that the majority of the floor drains contained no staining or only minor staining apparently from the water treatment materials. Petroleum products or hazardous materials were not observed near the floor drains with the exception of the floor drain located in the Maintenance Building in the North Plant.

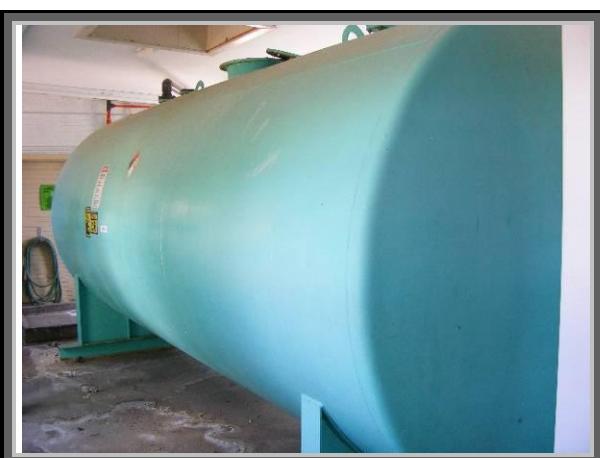
Photograph 17: 6,000 gal metal AST for Aluminum Sulfate located in the Chemical Mixing Bld. in the western portion of the South Plant.

During the site reconnaissance, Terracon observed eight ASTs, ranging in size from approximately 3,000 gallons to 6,500 gallons, and one 50,000 pound capacity silo. The ASTs appeared to be empty and were associated with former water treatment operations. Terracon observed labeling on the ASTs that indicated contents of bleach/chlorine and Aluminum sulfate. The silo reportedly was still partially full of Soda ash. Terracon observed minor staining associated with the ASTs. The ASTs and silo contained or previously contained materials that were water soluble and that treated the water to be used for human consumption. Based on the containers being apparently empty, minor amount of observed staining, and former contents, the ASTs do not constitute RECs to the site at this time. Based on the reported contents and observed site conditions, the silo does not constitute a REC to the site at this time. Although the ASTs and silo are not considered RECs, some residual chemicals may be present in each of the listed storage areas.

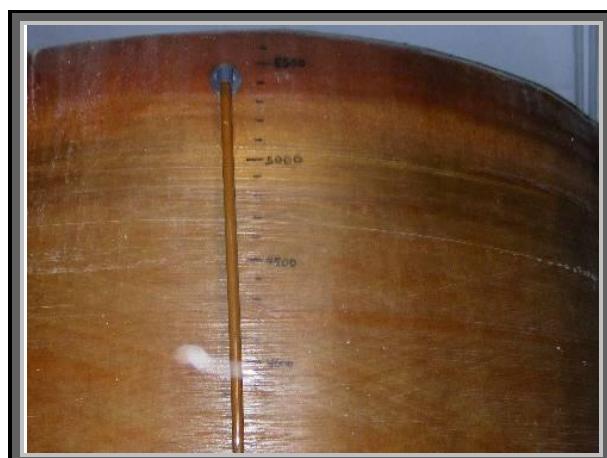
Photograph 18: 5,500 gal fiberglass AST for Aluminum Sulfate located in the Chemical Mixing Bld. in the western portion of the South Plant.

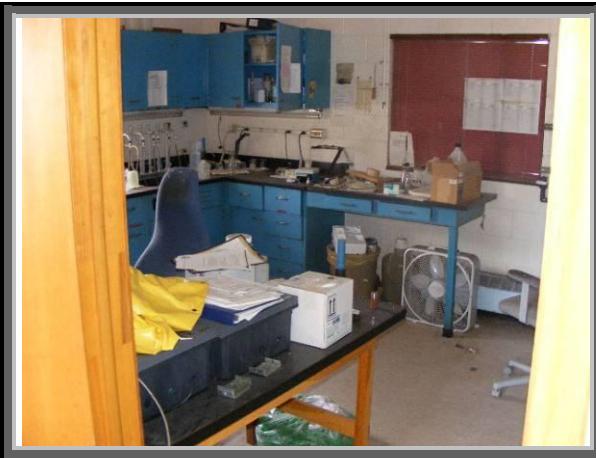
Photograph 21: Analytical Testing laboratory, located in the third level of the South Plant Main Building.

During the site reconnaissance Terracon observed an analytical testing laboratory located in the Main Building of the South Plant and the Filter Building of the North Plant. The South Plant laboratory contained laboratory equipment, utensils, and several containers 1-gallon or smaller of chemicals used to test water quality. The North Plant laboratory contained utensils and some lab equipment. No staining was observed associated with the chemical containers or the sink drains in the laboratories. Based on the small quantities of chemicals and observed site conditions, the testing laboratories do not constitute RECs to the site at this time.

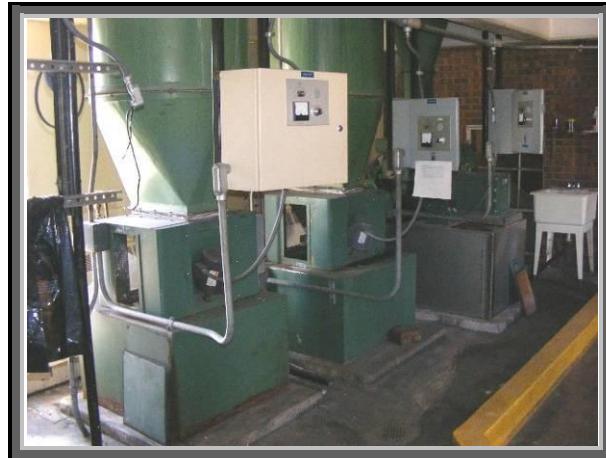
Photograph 22: Hoppers for inducing Soda Ash, Sodium Fluoride, and Activated Carbon, located in the upper level of the Main Bld.

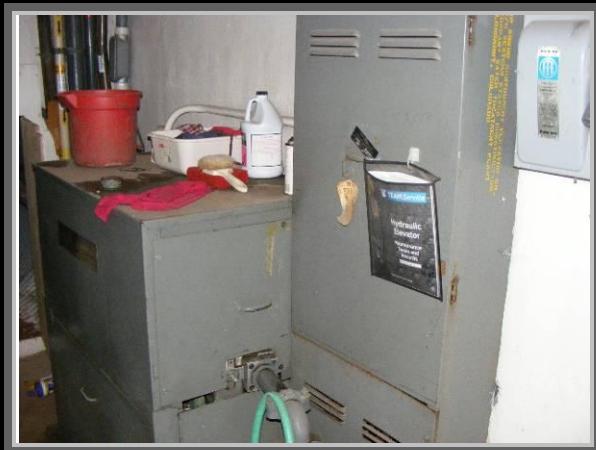
Photograph 23: View of the elevator controls and hydraulic fluid reservoir located in the basement of the South Plant Main Building.

- Terracon observed staining on the concrete floor under a hydraulic elevator fluid reservoir in the South Plant filtration building. The elevator pit was not accessible for a visual assessment. Based on the age of the building, the hydraulic fluid used in

the elevator system may have contained PCBs. Based on the staining observed and the potential for PCBs, this elevator is considered a REC.

During the site reconnaissance, Terracon observed a hydraulic elevator, located in the northern portion of the main building at the South Plant. Mr. Talbott stated that the elevator was installed during the plant renovation in the 1970's, and was used to transport people and materials used in the water treatment process. Access was not available to observe the elevator pit, but Terracon observed the elevator control area and the elevator's hydraulic reservoir. Terracon observed staining on the concrete floor under the hydraulic fluid pump and reservoir. Terracon observed hydraulic maintenance logs by ThyssenKrupp Elevator on the control mechanism dated 2004. The logs indicated that the system was operating normally and the tests were satisfactory. No information was observed for the elevator system prior to 2004. Based on the age of the elevator, it is possible that the hydraulic fluid used in the elevator contained PCBs. Based on the lack of information for the majority of the time the elevator was in operation, the age and type of system, the observed staining associated with the hydraulic system, the elevator located in the north side of the main building at the South Plant constitutes a REC to the site at this time.

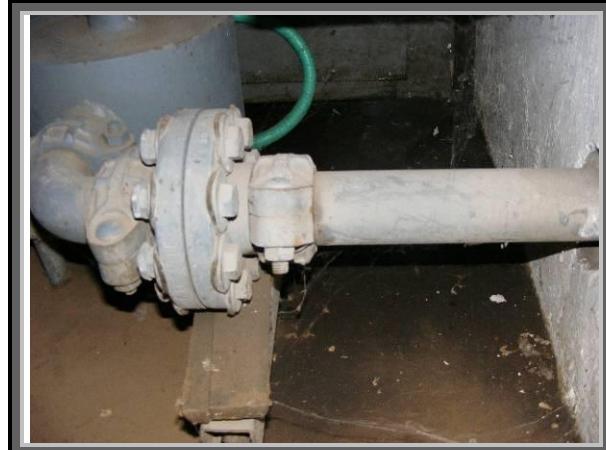
Photograph 24: Stained concrete associated with elevator hydraulic pump and reservoir.

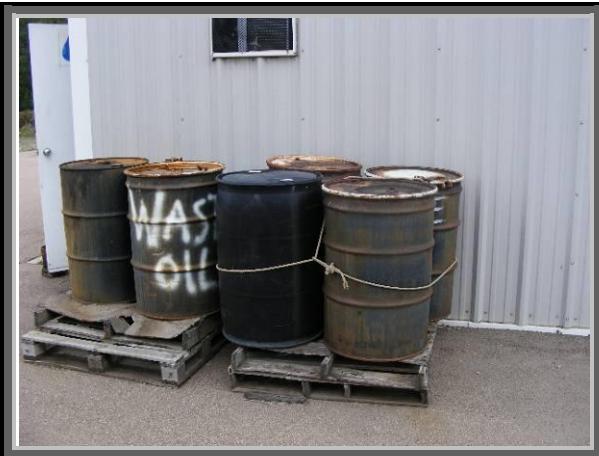
Photograph 25: 55-gallon drums, 4 empty and 2 partially full, located on the north side of the Equipment Storage Building.

During the site reconnaissance Terracon observed approximately twenty 55-gallon drums and barrels throughout the site that were partially full, and approximately twenty-nine 55-gallon drums that were apparently empty. Labeling on the containers indicated contents of waste oil, diesel fuel, and water treatment flocculent polymer. Releases or staining were not observed associated with the 55-gallon containers.

Based on the absence of staining or releases, the 5-gallon to 55-gallon containers do not constitute RECs to the site at this time.

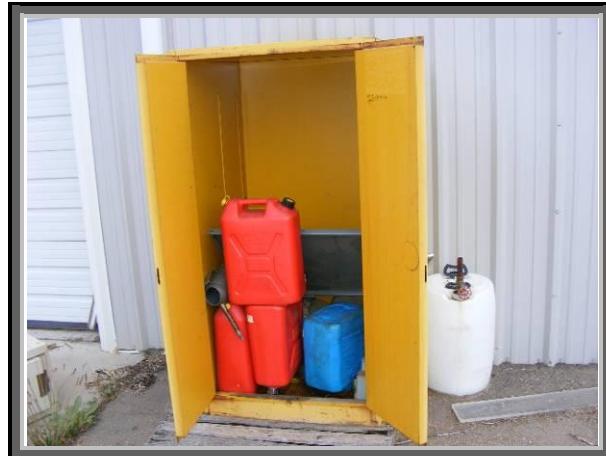
Photograph 26: 5-gallon containers of gasoline and kerosene located on the eastern side of the Equipment Storage Building.

Terracon observed approximately twenty-three 5-gallon partially full containers in buildings throughout the site. Labeling on the containers indicated contents of Food Grade HTC Oil, gasoline, kerosene, and chlorinated granules. Approximately ten 5-gallon and several smaller sized containers were observed in the Maintenance Building located in the eastern portion of the North Plant. The containers were partially full with labeling indicating contents of paint, hydraulic oil, antifreeze, paint thinner, weed killer, and vegetable oil.

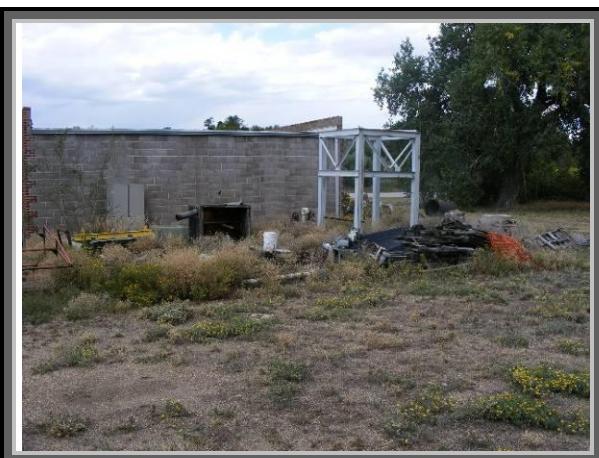
Photograph 27: View of operations debris located on the south side of the Clearwell in the eastern portion of the site.

During the site reconnaissance Terracon observed areas of debris - used operations equipment and parts located on the south side of the equipment storage building, the south side of the pump house and the clearwell building, and on the east side of the clearwell building at the South Plant. The materials observed consisted of plastic, metal, and wood. No staining or hazardous materials were observed associated with the debris piles. Based on the absence of observed staining or associated hazardous materials, the areas of debris do not constitute RECs to the site at this time.

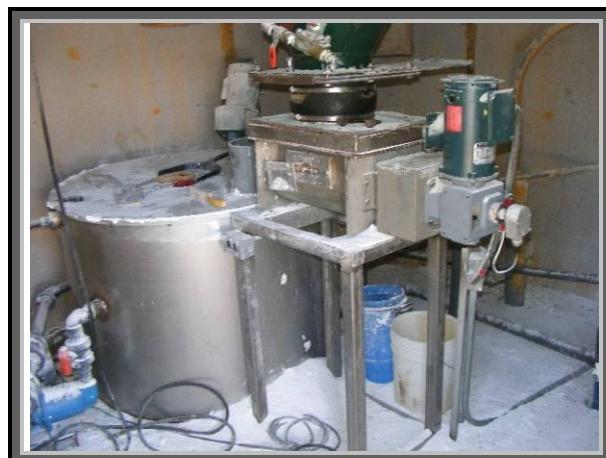
Photograph 28: View of vacuum system inside the Soda Ash Silo located in the eastern portion of the site.

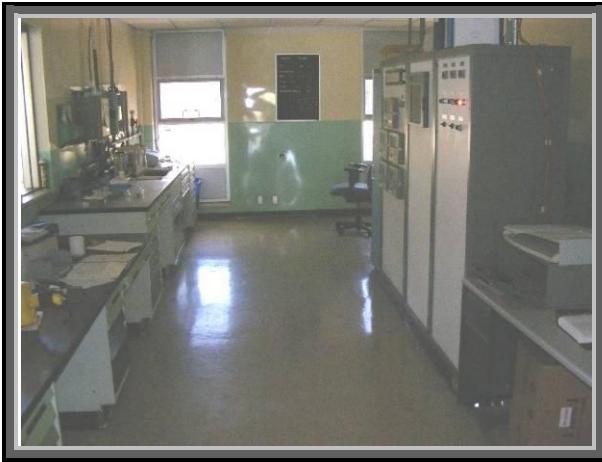
Photograph 13: View of the analytical testing laboratory located in the Filter Building.

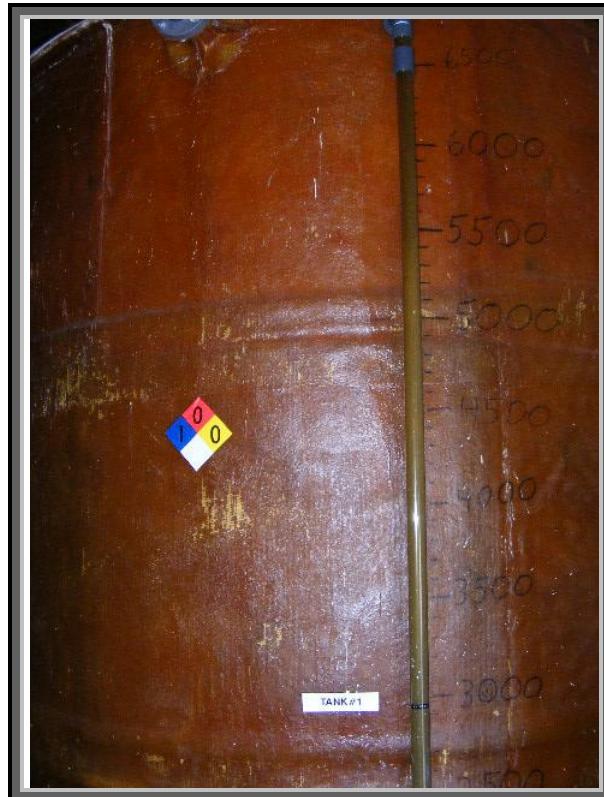
Photograph 16: 6,500 gal fiberlass AST for Aluminum Sulfate located in the Alum Storage Bld. in the western portion of the North Plant.

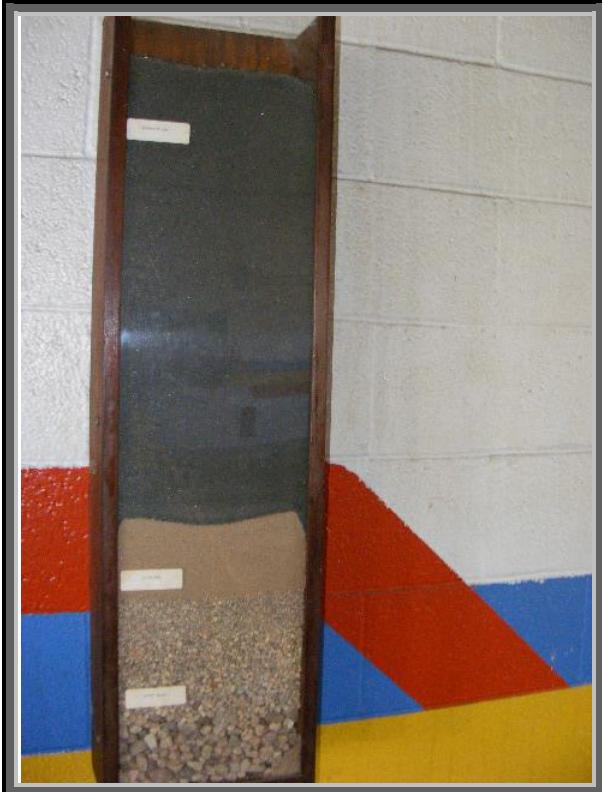
Photograph 19: View of filter material cross section – Anthracite Coal overlying graded sand and gravel.

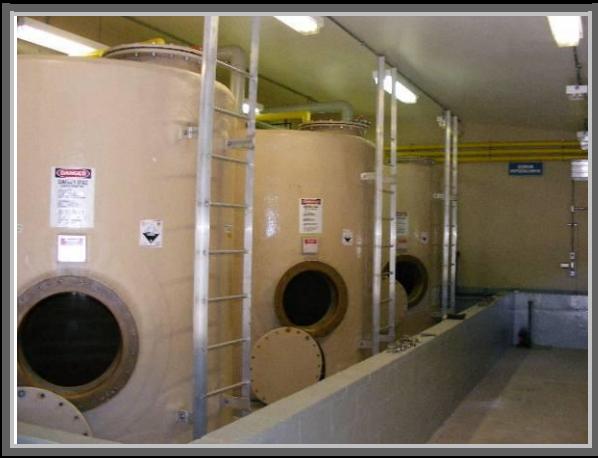
Photograph 22: Approx. 4,000 gal metal ASTs for Bleach located in the Bleach/Chlorine Bld. in the central portion of the North Plant.

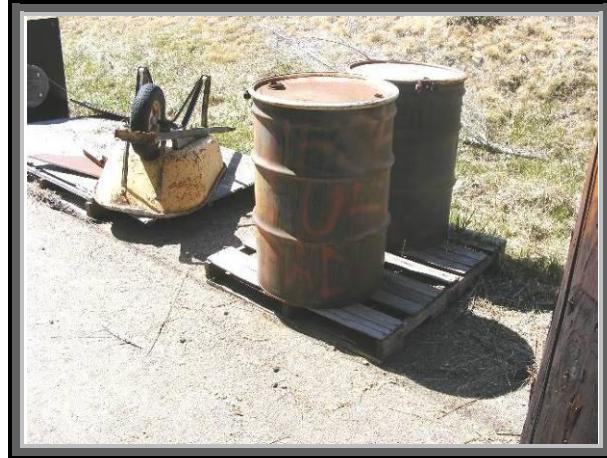
Photograph 23: Partially full 55-gallon drums, labeled "Diesel Fuel Pad", located in the northeastern portion of the site.

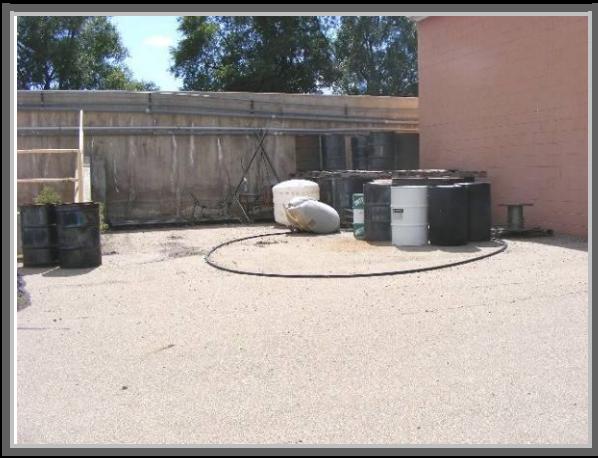
Photograph 24: Partially full and empty 55-gallon drums, located on the south side of the Floc-Sed Basin.

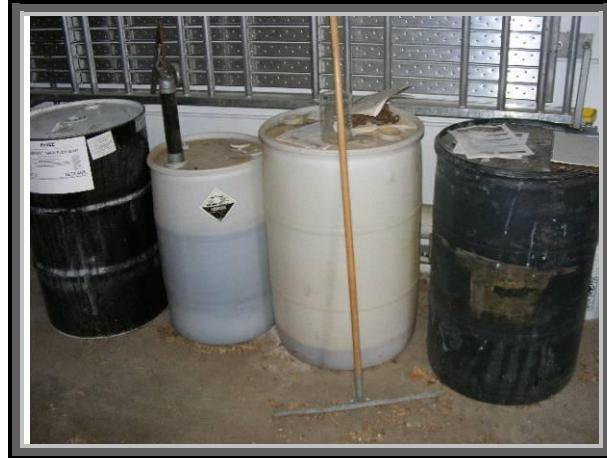
Photograph 25: Partially full 55 and 35-gallon drums, labeled "Floran Catalyst", located in the lower level of the Filter Building.

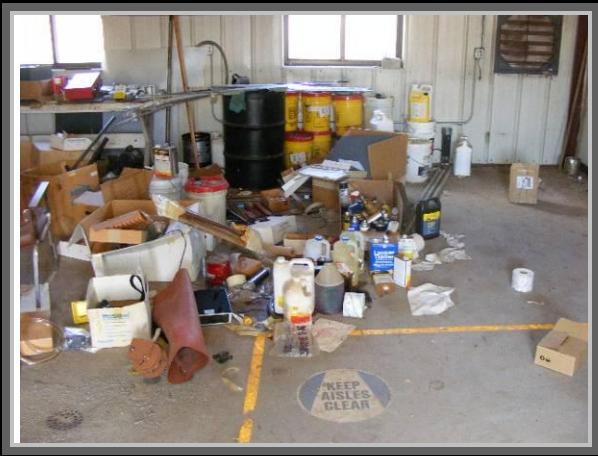
Photograph 26: Containers of hazardous materials near the floor drain in the Maintenance Building located in the eastern portion of the site.

Terracon observed several small containers and 5-gallon buckets containing petroleum products or hazardous materials within approximately 15 feet of the floor drain in the Maintenance Building. No staining was observed on the floor drain. Based on review of historical aerial photographs, the building was apparently built in the late 1970's. Mr. Talbott was not aware of vehicles being serviced at the maintenance building on site. Based on the length of time the Maintenance Building has been in place, building use, possible presence and use of hazardous materials and petroleum products identified from MSDS information, and proximity of observed hazardous materials and petroleum products, potential discharges to the interior floor drain in the Maintenance Building at the North Plant is considered a REC to the site at this time.

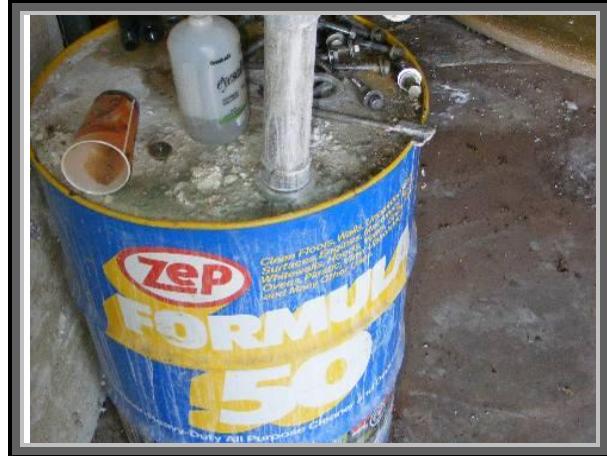
Photograph 27: 35-gallon drum with hand pump labeled "Zep Formula 50", located in the Alum Storage Building.
